HOME REPORT

KIRK COTTAGE
55 THOM STREET
HOPEMAN
ELGIN
IV30 5TB

Energy Performance Certificate (EPC)

Single Survey

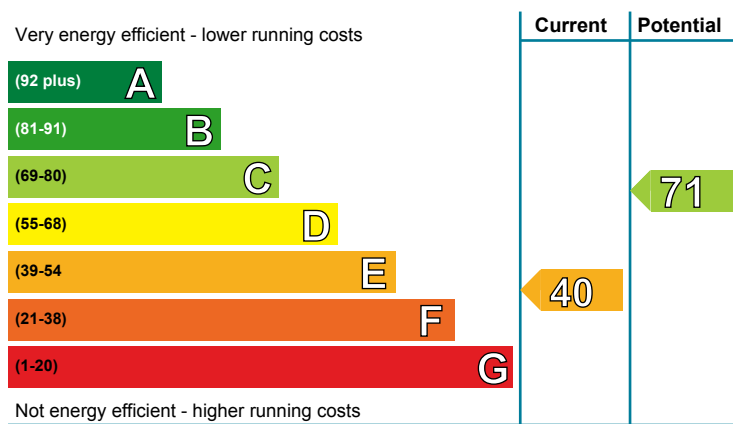
Energy Efficiency Rating

This graph shows the current efficiency of your home, taking into account both energy efficiency and fuel costs. The higher this rating, the lower your fuel bills are likely to be.

Your current rating is **band E (40)**. The average rating for EPCs in Scotland is **band D (61)**.

The potential rating shows the effect of undertaking all of the improvement measures listed within your recommendations report.
